LUSCOMBE AIRPLANE CORPORATION  
P.O. Box 2128, Dallas 1, Texas

SERVICE BULLETIN NUMBER 1-48

SUBJECT: Decker 501A Tail Installation on Model 8 Silvaire,  
Serial Nos. 5824 to 5854.

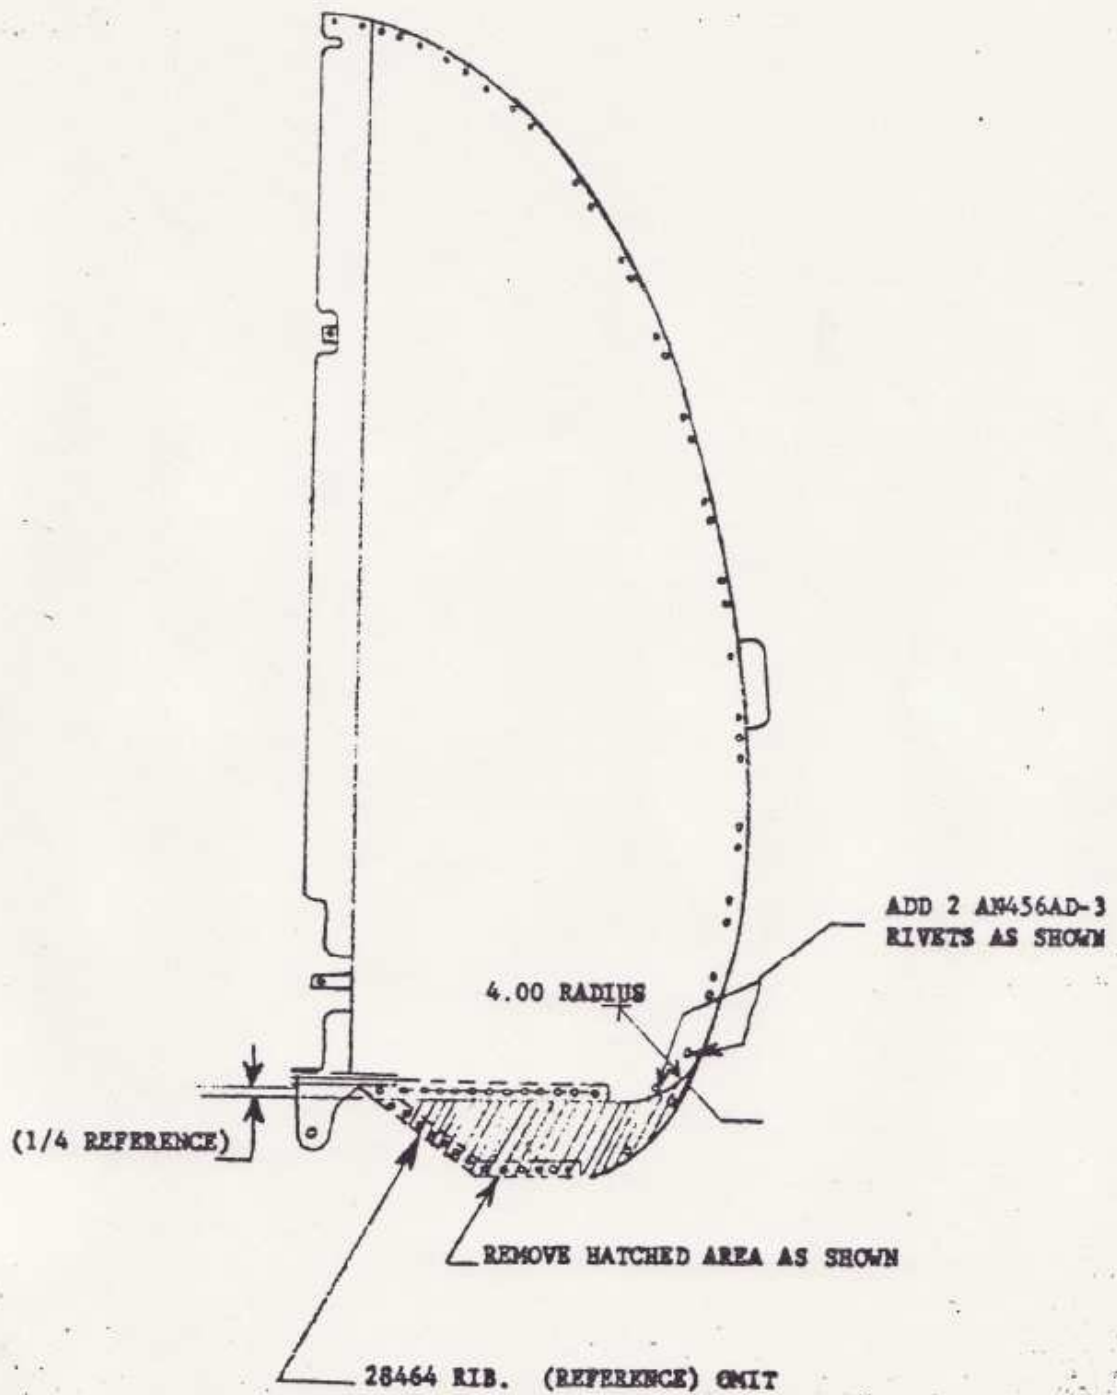
DECKER TAIL WHEEL MODEL 501A

It has been found that the height of the steerable mechanism on the Decker 501A tail wheel as installed on the above aircraft causes interference with the lower edge of the rudder under certain conditions. This condition has been corrected on subsequent aircraft by removing the lower portion of the rudder, as shown on the attached sketch. It is suggested that the modification described be incorporated on your aircraft at the earliest opportunity. This revision, which can be accomplished without removing the rudder from the aircraft, is approved and recommended by the CAA.
