THE DON LUSCOMBE AVIATION HISTORY FOUNDATION

Luscombe Silvaire model 8 Aircraft Type Certificate Holder

SERVICE RECOMMENDATION #4

Applicability: All Luscombe model 8 series aircraft.

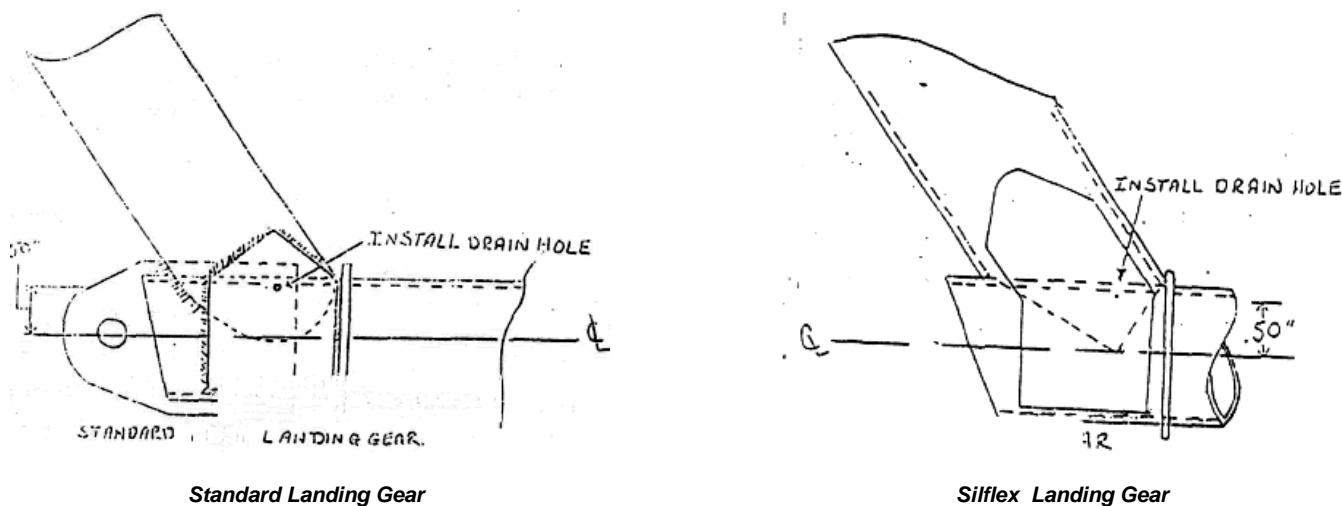
FIGURE A

Background: NTSB and several owners have reported failure of the main landing gear leg within the 2" area just above the axle weldment (see fig A). Corrosion damage in this area can be exacerbated by loose attachments and fittings to the gear leg which can lead to metal fatigue. The past few years of Luscombe operations have been punctuated by owner/operator reports of rust damage, or in several occasions, complete failure of the lower main gear leg from corrosion just above the axle shaft weld joint. Mechanics in the field have also reported "weld" repairs to gearlegs which are not authorized on Luscombe landing gear.

Condensation within the gear leg lets moisture accumulate in the sealed leg between the axle tube and the first hole up the leg where the brake pulley mounting bolt pierces the assembly, which makes this section particularly susceptible to corrosion.

Compliance procedure: Remove the gear fairings as necessary to gain access to the lower gear leg area for inspection. Locate the reinforcement patch on the rear side of the gearleg and centerpunch the reinforcement as noted in figure A. Drill the reinforcement and gearleg with a small hole (1/8") in the center of the reinforcement patch area where the upper leg joins the axle, just slightly (1/2") above the axle centerline. This drain hole at the rear of the gear leg will allow any trapped moisture to drain from the leg and minimize corrosion to this area. It will also allow some "drying air" access to the area to keep corrosion to a minimum.

Inspect: Inspect the area and note any water draining, or rust dust/flakes that might come out on the drill or a wire inserted into the hole. Use a small ballpeen hammer and scratch awl or punch to prick the base of the upper gear leg above the weld. If you are able to pierce the tubing, replace the lower leg with a new unit. Legs with no water or rust indicated may be returned to service. If there is any question as to the integrity of the leg, complete items 1-3 below. Treatment in accordance with #3 below is advised. NOTE: Inspect for weld repairs to the gear leg. Weld repairs to the gear leg is not an approved procedure. Components containing weld repairs are considered UNAIRWORTHY and must be removed and replaced because welding destroys the heat treat properties of the part.
